NAVAL POSTGRADUATE SCHOOL

THESIS

**THE EFFECT OF APPLIED TENSILE STRESS
ON LOCALIZED CORROSION IN SENSITIZED
AA5083**

September 2015

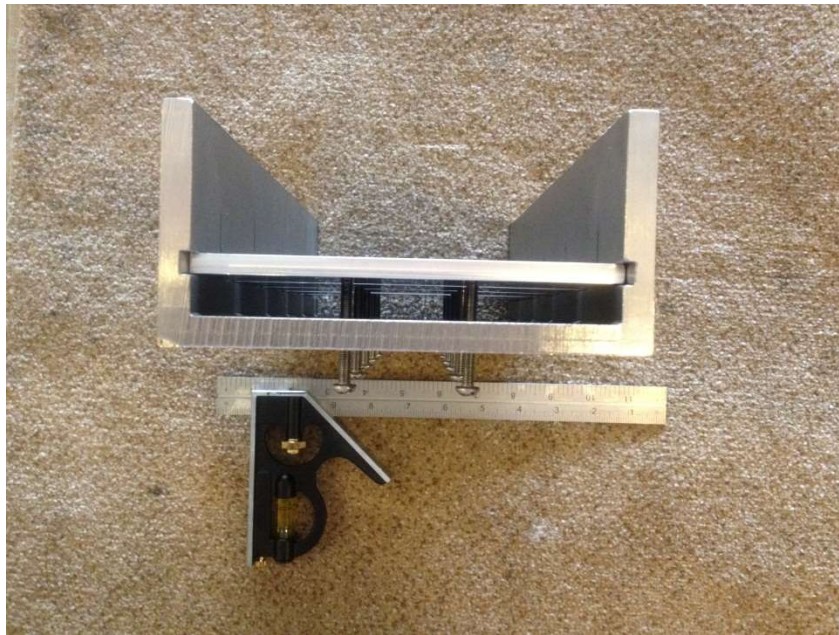
Figure 13. Photograph of stainless steel 4-point bending rig used to apply elastic stress to aluminum plate samples, from [8].

The four point bending apparatus was designed in accordance with ASTM-G39 (see Figure 12). The bend rig was made of 316 stainless-steel and utilized #10 stainless steel screws with 32 threads per inch to apply stress to the aluminum coupons (see Figure 13).

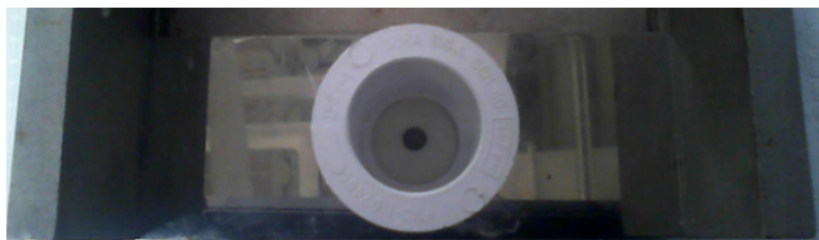
Figure 15. Top view of cup mounted to top of sample with double-sided tape. The area exposed to saltwater is punched through the tape.

the bend apparatus of approximately 100 MPa or 200 MPa. Screws were turned until the tensile stress on the top surface reached the desired level. Non-conductive plastic cups of 50 mm in diameter were sealed to the surface of the plate using extra strength 3M double sided tape. A 6 mm diameter hole (exposed surface area of 0.283 cm^2) was punched through the tape to control the aluminum plate exposed area to aerated, 0.6 M NaCl, synthetic saltwater (pH was adjusted to 8.3 using 0.1M NaOH) while under applied elastic stress (see Figure 15). Gamry Framework and Echem Analyst software was used to perform potentiodynamic and potentiostatic testing and analysis on the samples under stress. A tri-electrode cell (see Figure 16) was created by using the plate as the working electrode (WE) with a Fisher Scientific Accumet glass body Ag/AgCl mercury free standard reference cell as the reference electrode (RE) and a graphite rod counter electrode (CE). The bend rig, aluminum sample, and three electrode cell was placed into a Faraday cage to prevent stray voltages interfering with the electrochemical experiments. The Faraday cage consisted of a non-conductive container wrapped in heavy duty aluminum foil.

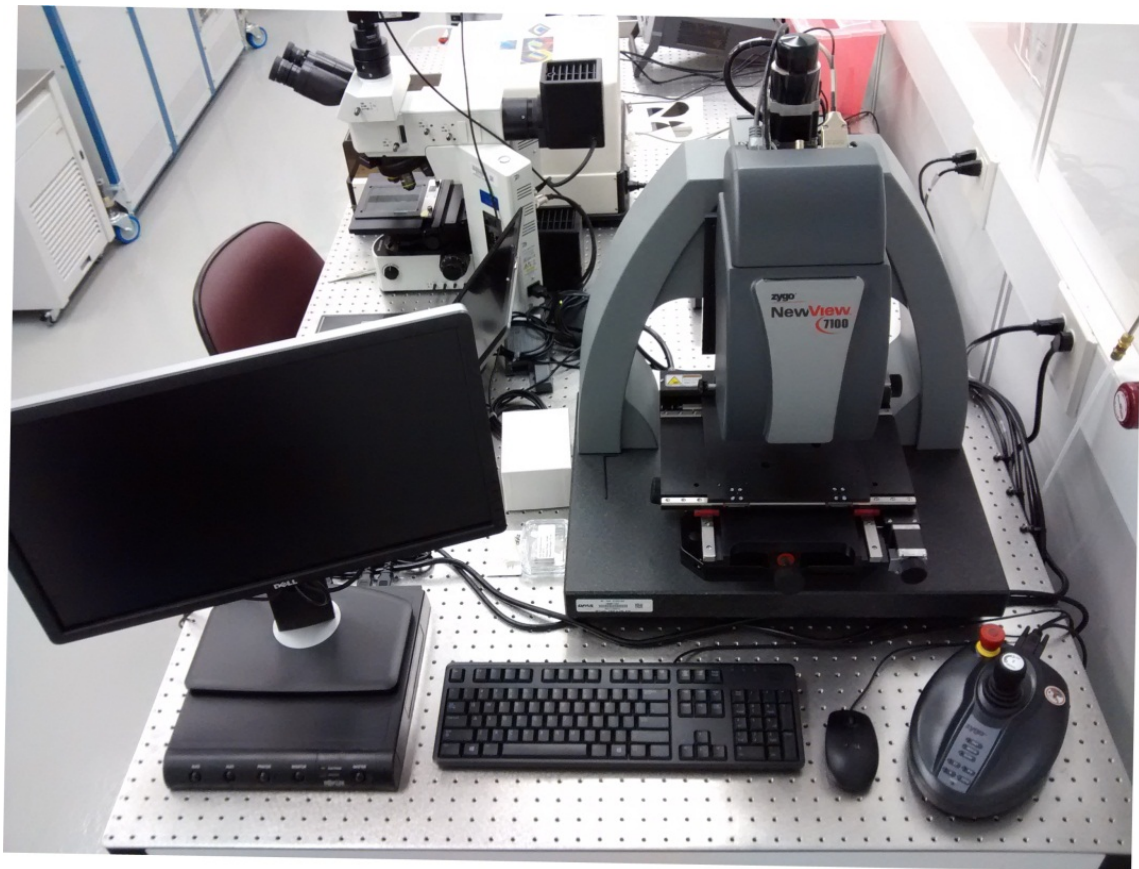
Figure 17. Optical Profilometer Zygo NewView 7100 with MetroPro software.

The degree and distribution of localized corrosion was measured by a combination of optical and confocal microscopies using the Zygo NewView 7100 optical profilometer with MetroPro software (see Figure 17). Optical profilometry scans (image intensity maps) and depth images were taken of the exposed surfaces area and the whole exposed surface area image was “stitched” together to form one image. The double sided tape on the sample allowed for only the exposed surface area of the sample to be scanned. Light intensity of the scan was adjusted based on the reflectivity of the sample surface. Dual light sources were required for the corroded surfaces based on the non-reflective nature of the corrosion products and the depth of corrosion damage. The higher light intensity allowed for the corrosive areas and the large pits to be scanned, while the lower light intensity was used for the areas with high reflectivity. The Dual Light Stitch program built in MetroPro software compared the high and low light scan and automatically used the best image areas from each scan to produce the overall stitched image. Black areas in the scans indicated that no data was obtained from that area. The intensity image map is the stitched optical image at 100x magnification. Sample orientation was scanned in accordance with Figure 18.
